# Manhole Inspection Summary

Manhole # S41A\_\_001MH

**Location** Address: **N CENTRAL AVE**

Cross Street: **ORLEANS ST**

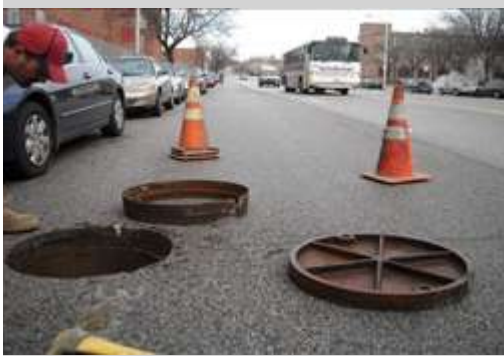
Location View

LOOKING NORTHBOUND ON N  
CENTRAL AVE

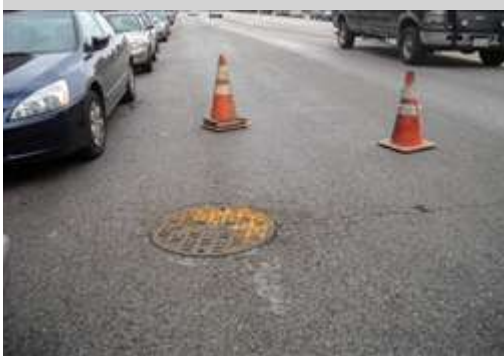
Comments **OBSERVED THAT AN ADJUSTABLE FRAME WAS BENT AROUND MANHOLE LID. PRYING ON COVER PULLED ENTIRE FRAME FROM GROUND AS SEEN IN PHOTO. WE CLEANED AROUND THE INSIDE OF THE FRAME AND RESET ADJUSTABLE FRAME INTO HOLE. PREVIOUS 24" LID WAS CRACKED AND NEEDED TO BE**

REPLACED WITH NEW MANHOLE LID

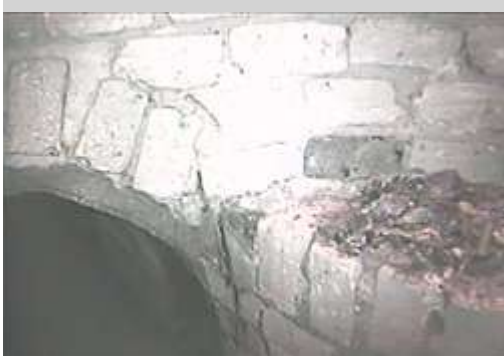
Defect 1

THERE IS A CRACK RUNNING ALONG  
THE RIGHT SIDE OF THE PIPE  
CONNECTION

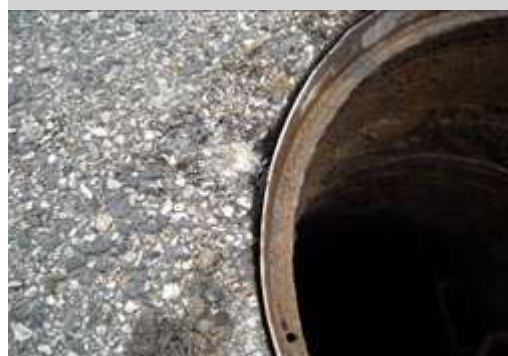
Defect 3

**Frame** Offset: **0** (in.) Condition: ☐ Sound ☐ Cracked ☒ **Leaks**

FRAME LEAKS FROM AROUND  
OUTSIDE - IS ADJUSTABLE FRAME

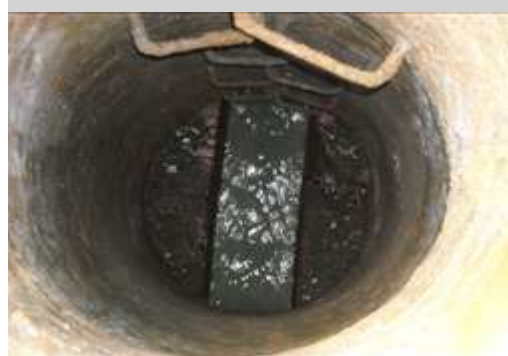
Defect 2

**Steps** Count: **9** Missing: **0** ☒ **Corroded**

corroded steps

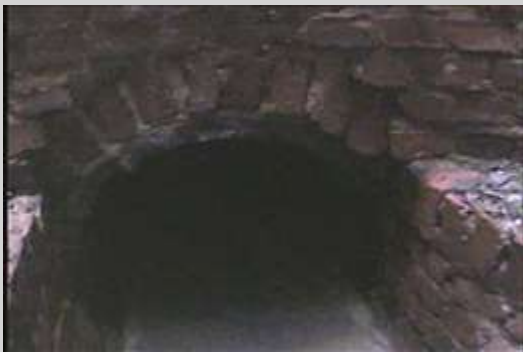
12 O'Clock Outflow

Pipe Height: **25.2** (in.) Rod and Bar (Angled)  
Pipe Material: **Concrete** ☐ Pipe Lined  
Invert Depth: **16.49** (ft.) Flow Characteristics: **Fast**  
Deposits: ☒ None ☐ Mud ☐ Sludge ☐ Debris ☐ Grease  
Silt Depth: **0** (in.) Deposits Extent:  
Infiltration: **None** Pipe Seal Cond: **Cracked**

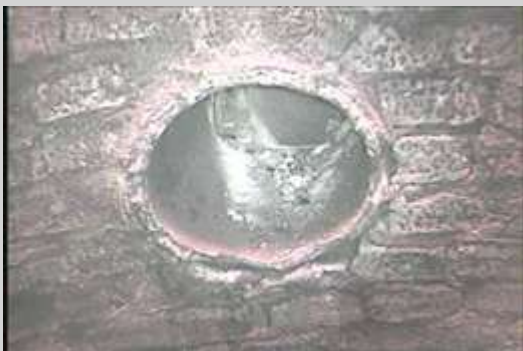
3 O'Clock Inflow

Pipe Height: **10.8** (in.) Rod and Bar (Angled)  
Pipe Material: **Clay** ☐ Pipe Lined  
Invert Depth: **8.90** (ft.) Flow Characteristics: **Slow**  
Deposits: ☐ None ☐ Mud ☒ **Sludge** ☐ Debris ☐ Grease  
Silt Depth: **2** (in.) Deposits Extent: **Light**  
Infiltration: **None** Pipe Seal Cond: **Sound**
